Cem-FIL® GRC Renovation

Santiago Bernabeu Football Stadium

Case Study_Santiago Bernebeu_ww_11-2008_Rev1

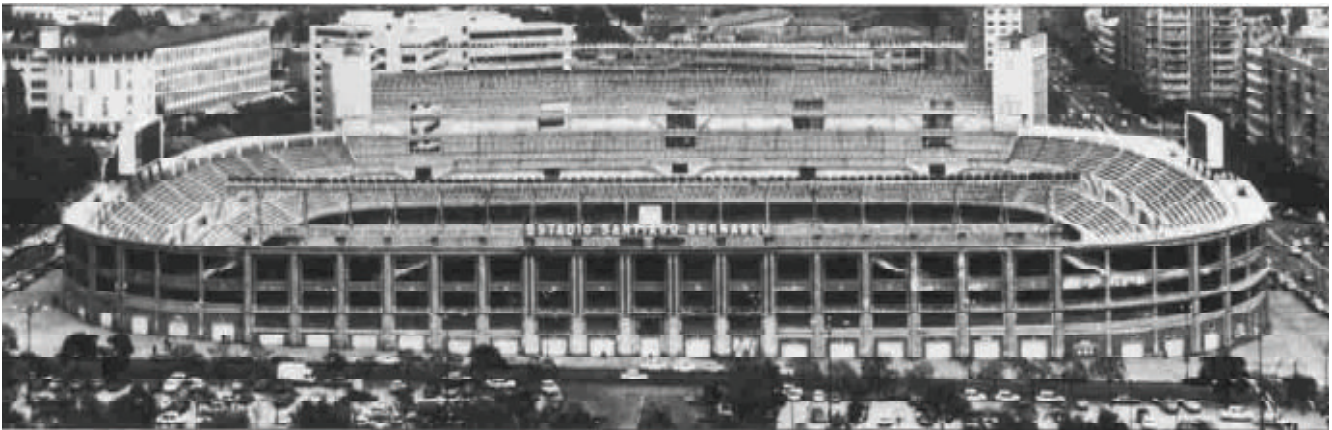
Fig. 1: The Original Stadium, as constructed in 1950

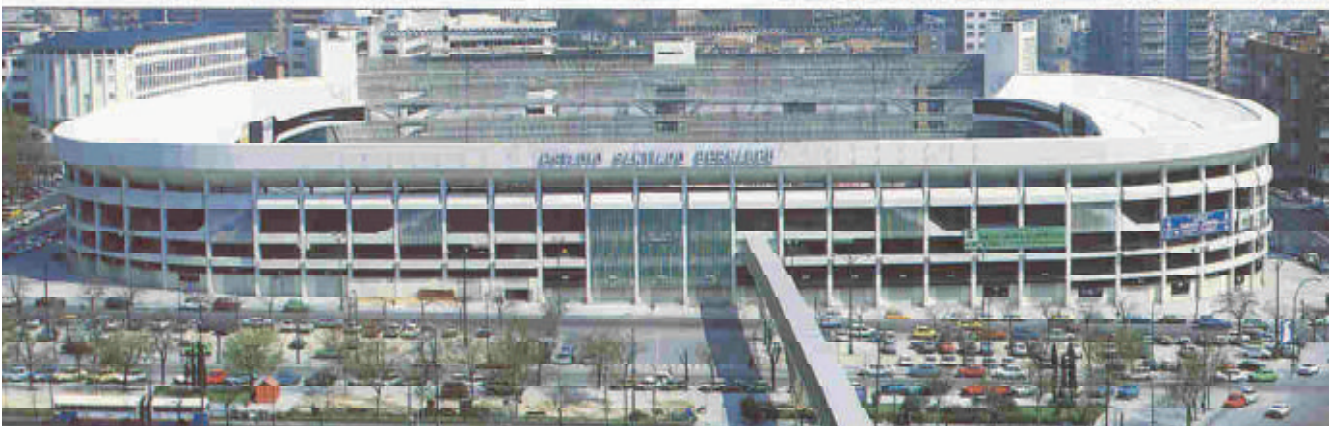
Fig. 2: After the first refurbishment, for the World Cup Championships in 1982

This was the second refurbishment for the famous stadium which was built in 1950. It was first refurbished using GRC architectural components ahead of the World Cup Championships held in Madrid in 1982. At that time some 20,000m² of GRC components were specified for column cladding, inner and outer detailing to the roof canopy and modular portico units.

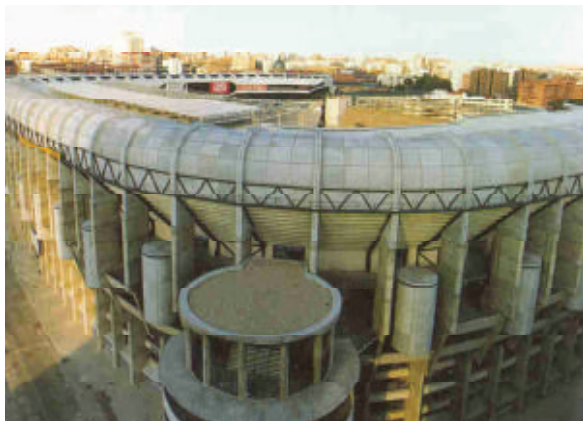
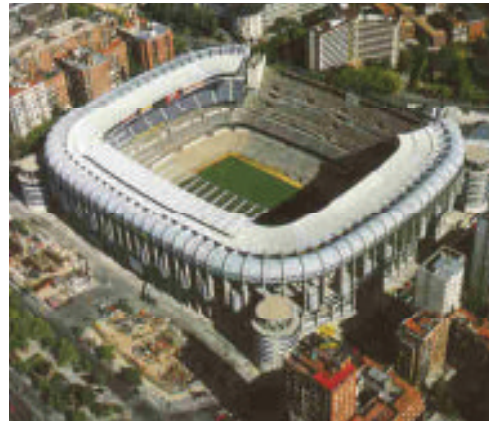
Figs. 3 & 4: The Santiago Bernebeu Stadium after the second refurbishment to new meet UEFA Regulations

The new enlargement, to meet the UEFA regulations on spectator seating, made it necessary to extend the stadium upward and outward to create a second tier of seating. In order to achieve this economically, the existing steel structure was extended and this in turn, placed a maximum weight limitation of 53kg/m² on the cladding panels to be used.

GRC provided a perfect solution despite the relatively large spans to be covered in some areas of the structure and the projected heavy wind loading. Due to the large panel size the average joint size was 24mm. The contract called for a variety of GRC components which were manufactured by Cem-FIL® GRC producer Huarte SA.

A number of differing cladding panels, both flat and slightly curved were produced in sandwich form, to a maximum size of 10m². Careful analysis was performed of the projected wind loading over the aerodynamic shape of the roof structure, and panels were fixed to the existing purlins by means of simple fish plates and angle bars.
