PRECAST INSULATED WALL PANELS

Hospital for the Elderly, Stavanger Norway

CEM-FIL MINIBARS™
High Performance Composite
Macrofiber

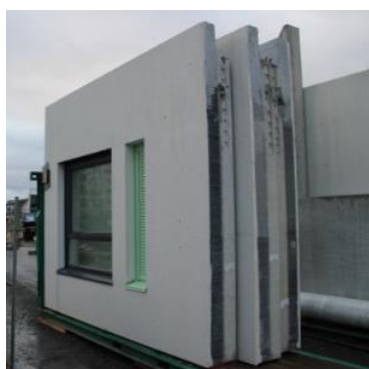
Precast insulated wall panels delivered to site with integrated windows and blinds

For this 6-story hospital building project in Stavanger, the precaster was asked to supply architectural insulated wall panels that were lighter and thinner in profile than standard panels, while also installing windows and blinds at the factory during production.

By replacing all the welded wire reinforcing (WWR) steel mesh and rebar with Cem-FIL MiniBars™ corrosion-free composite macrofiber, the need for cover concrete was lowered, and the outer wythe thickness was reduced by 50%.

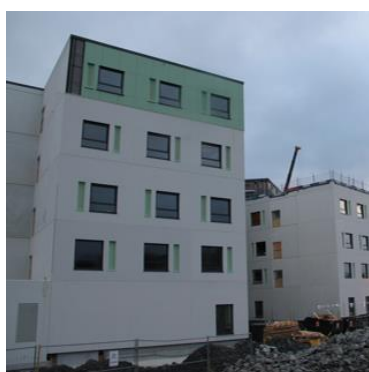
Precast insulated façade panels in place
